TECHNICAL NOTE

Date: 20th August 2024 Ref: 579 Raised by: AR Distributed to: as required

Updating the firmware on 32-bit SD-Rack DAC cards (P16336 variant)

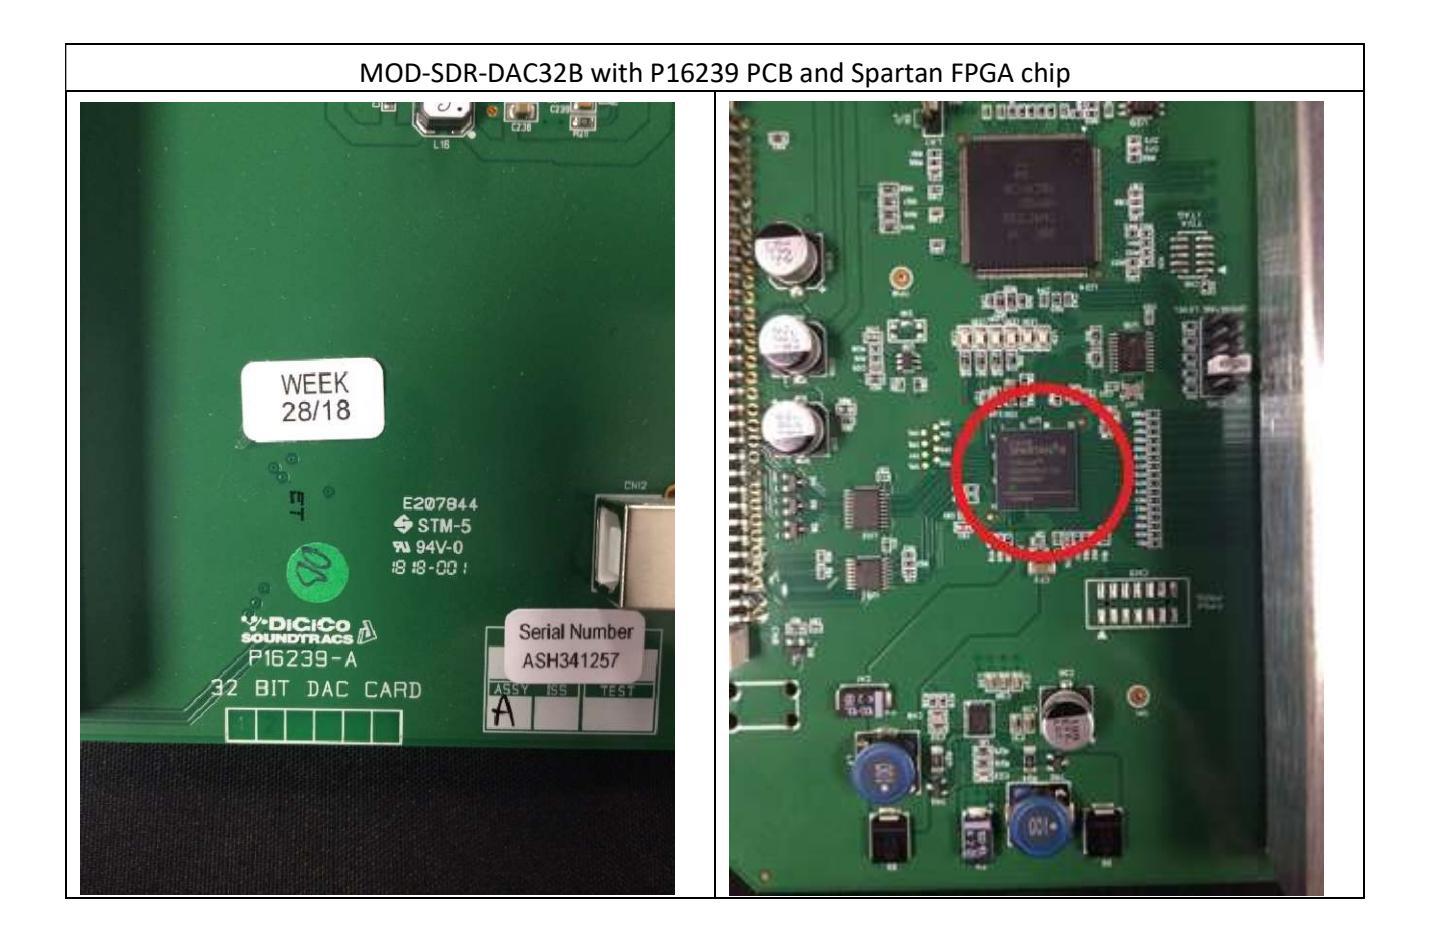
This section provides the information for correctly identifying the type of 32-bit DAC cards in use. Earlier 32-bit DAC cards use a Spartan FPGA chip, and the PCB board is part number P16239. The description printed on the card is '32 BIT DAC CARD' (see pictures below).

These cards are unaffected and DO NOT require any firmware update.

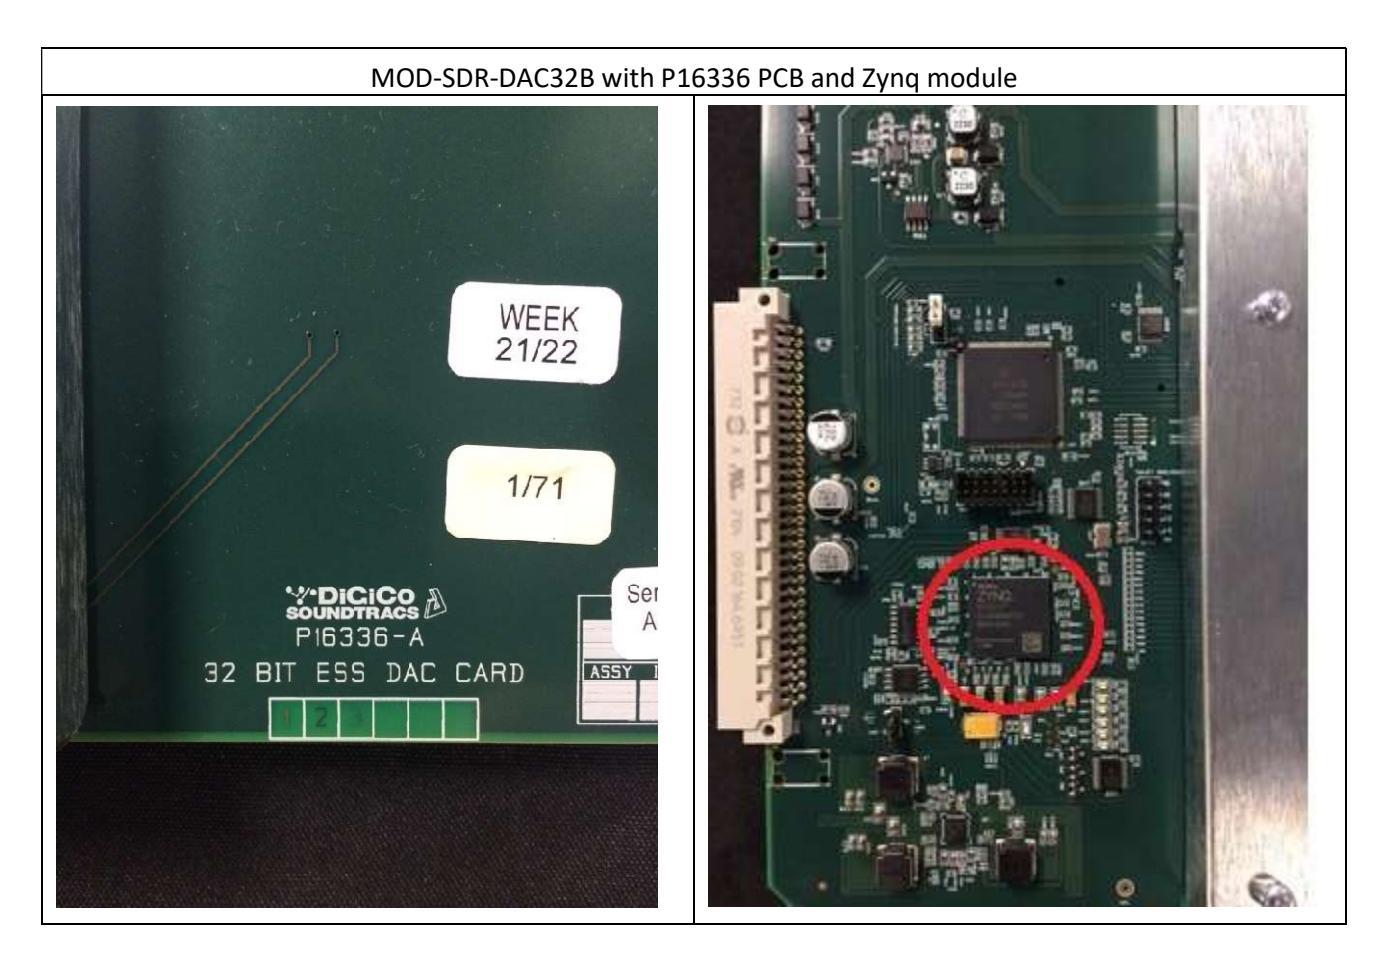
Later DAC cards (introduced from early 2022) use a Zynq chip, and the PCB board is part number P16336. The description printed on the card is '32 BIT ESS DAC CARD' (see pictures below).

The firmware update process described below is only intended for these cards.
