TECHNICAL NOTE

ref 445

SD12 - Changing worksurface Baud Rate for V1090+

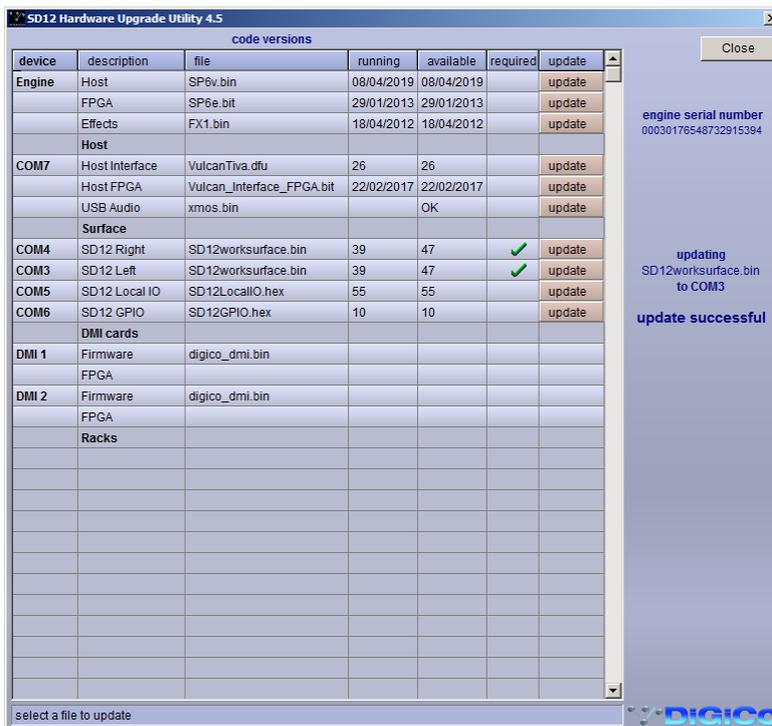
When both surfaces have been updated the panel should look like this – please note that it appears to still require an update – this is just a symptom of not having completed the following part of the process involving the change of Baud rate – see next step...

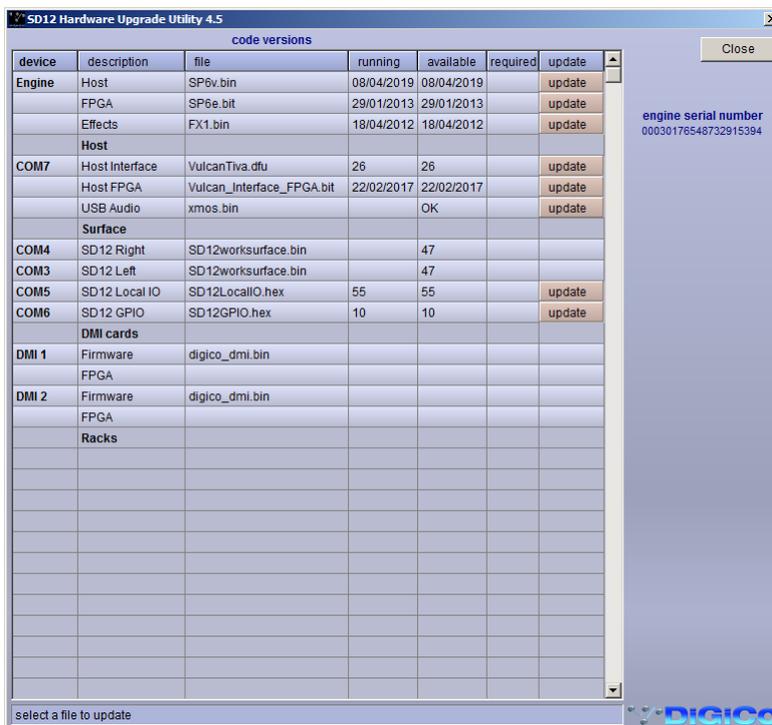
If you close and reopen the update hardware application the panel will now appear like the image below and not indicate any "Running" surface code – don't worry about this – just proceed to the next step.
