TECHNICAL NOTE

Date: 20th August 2024 Ref: 579 Raised by: AR Distributed to: as required

Updating the firmware on 32-bit SD-Rack DAC cards (P16336 variant)

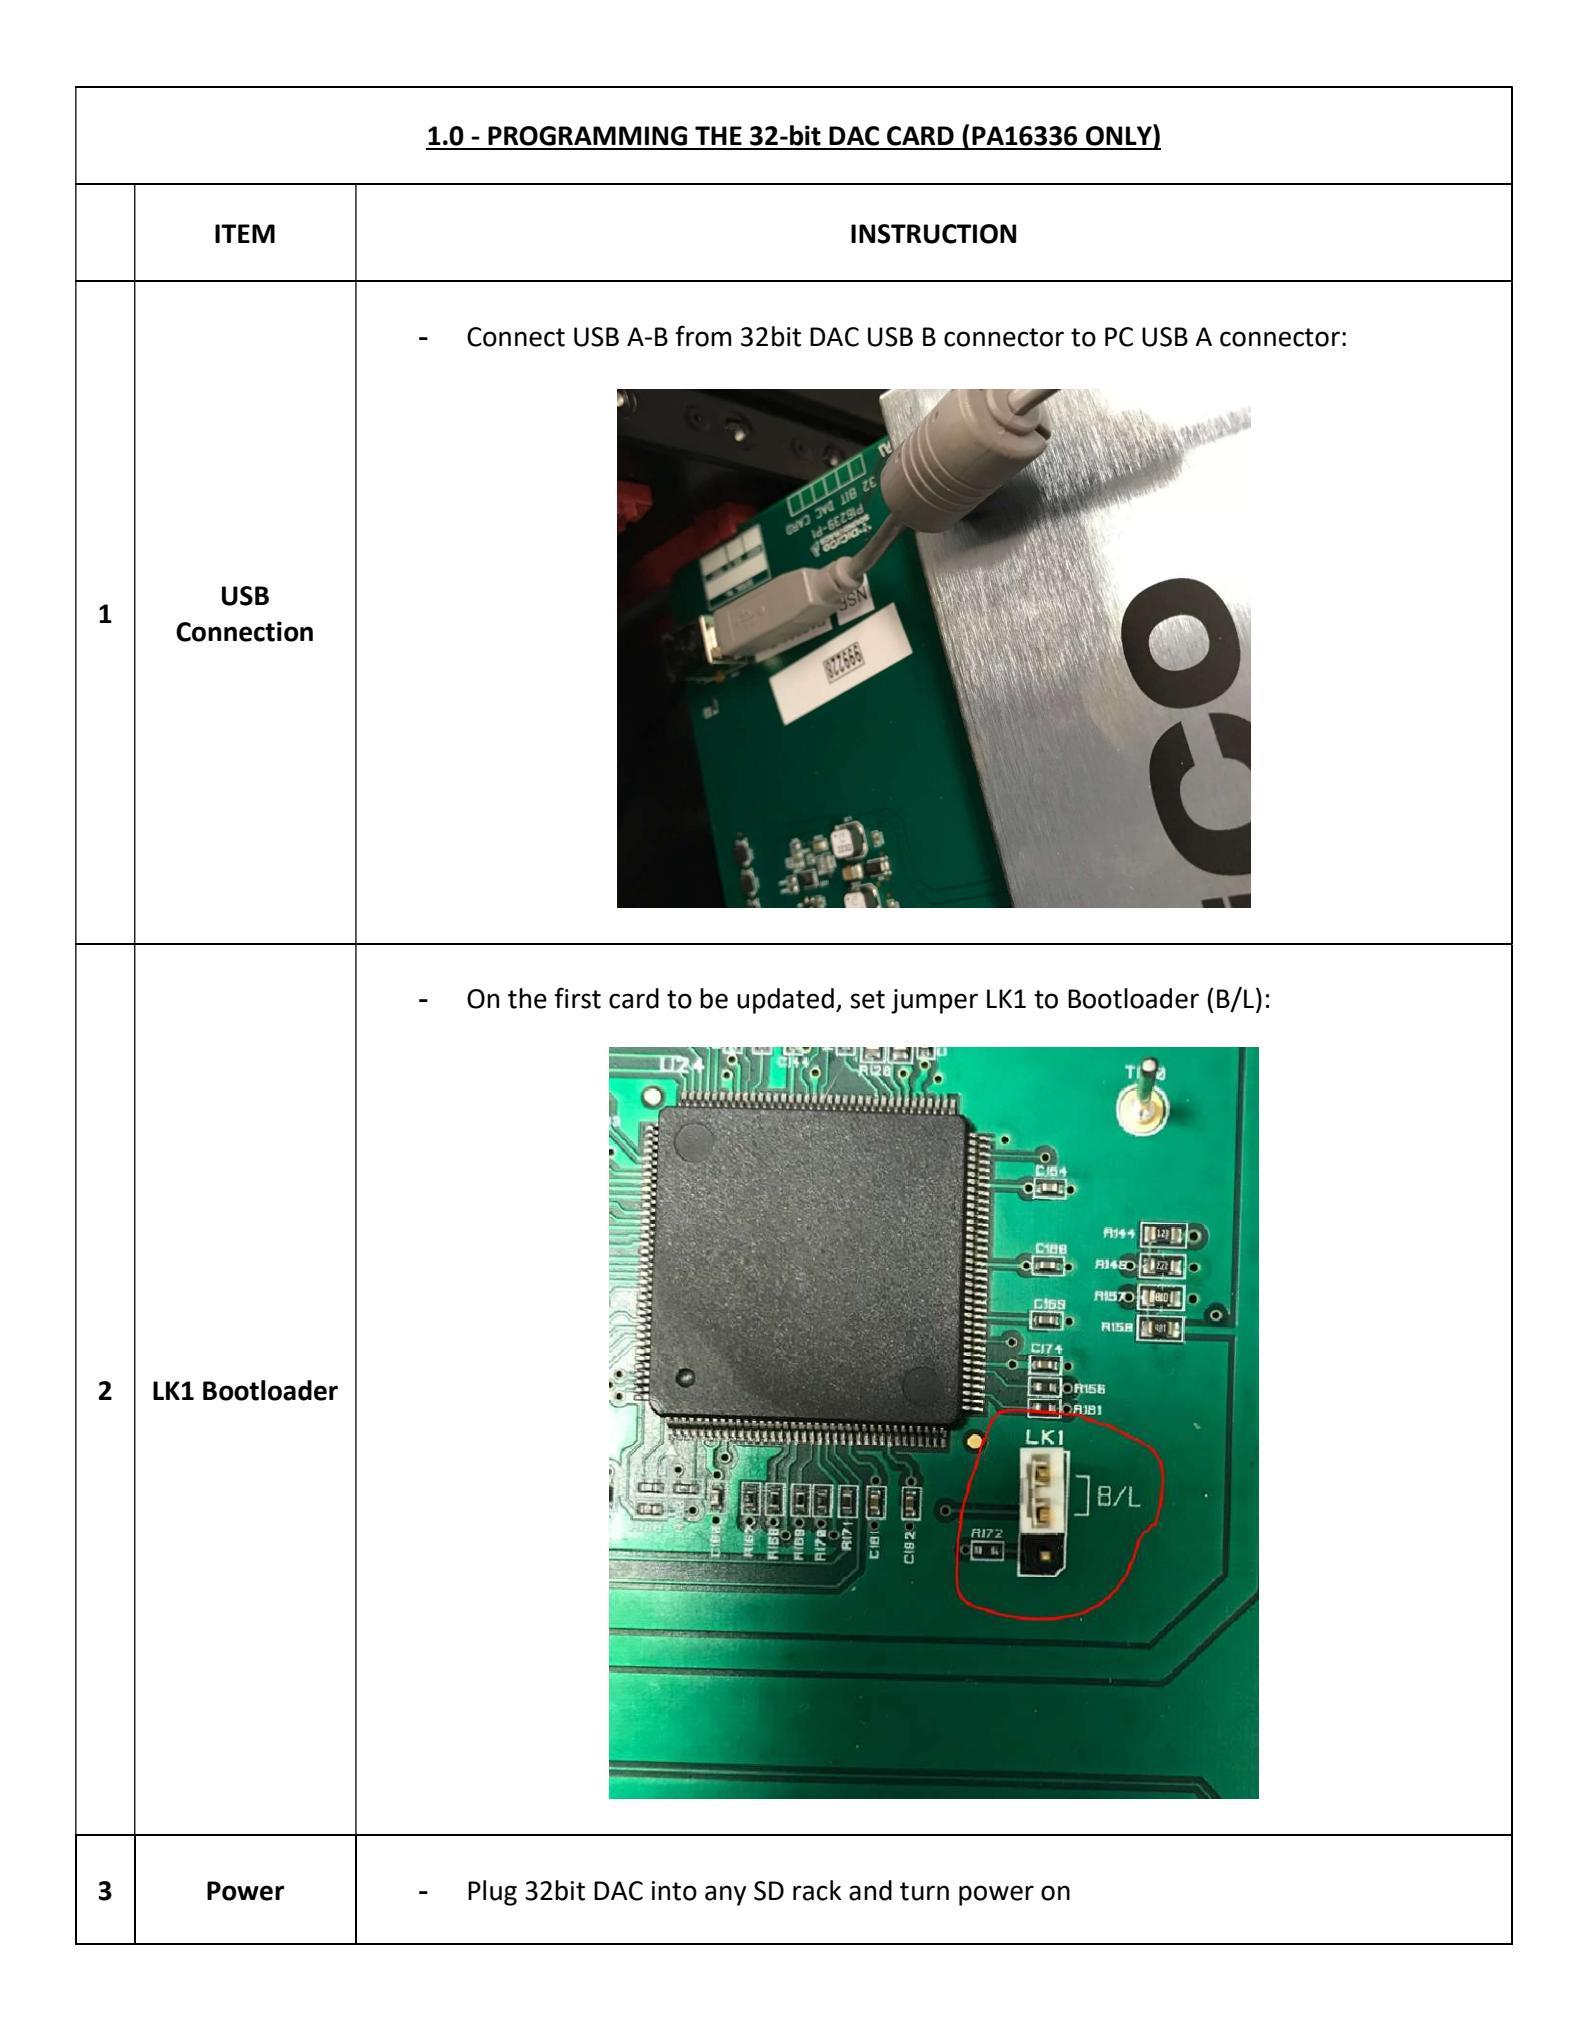
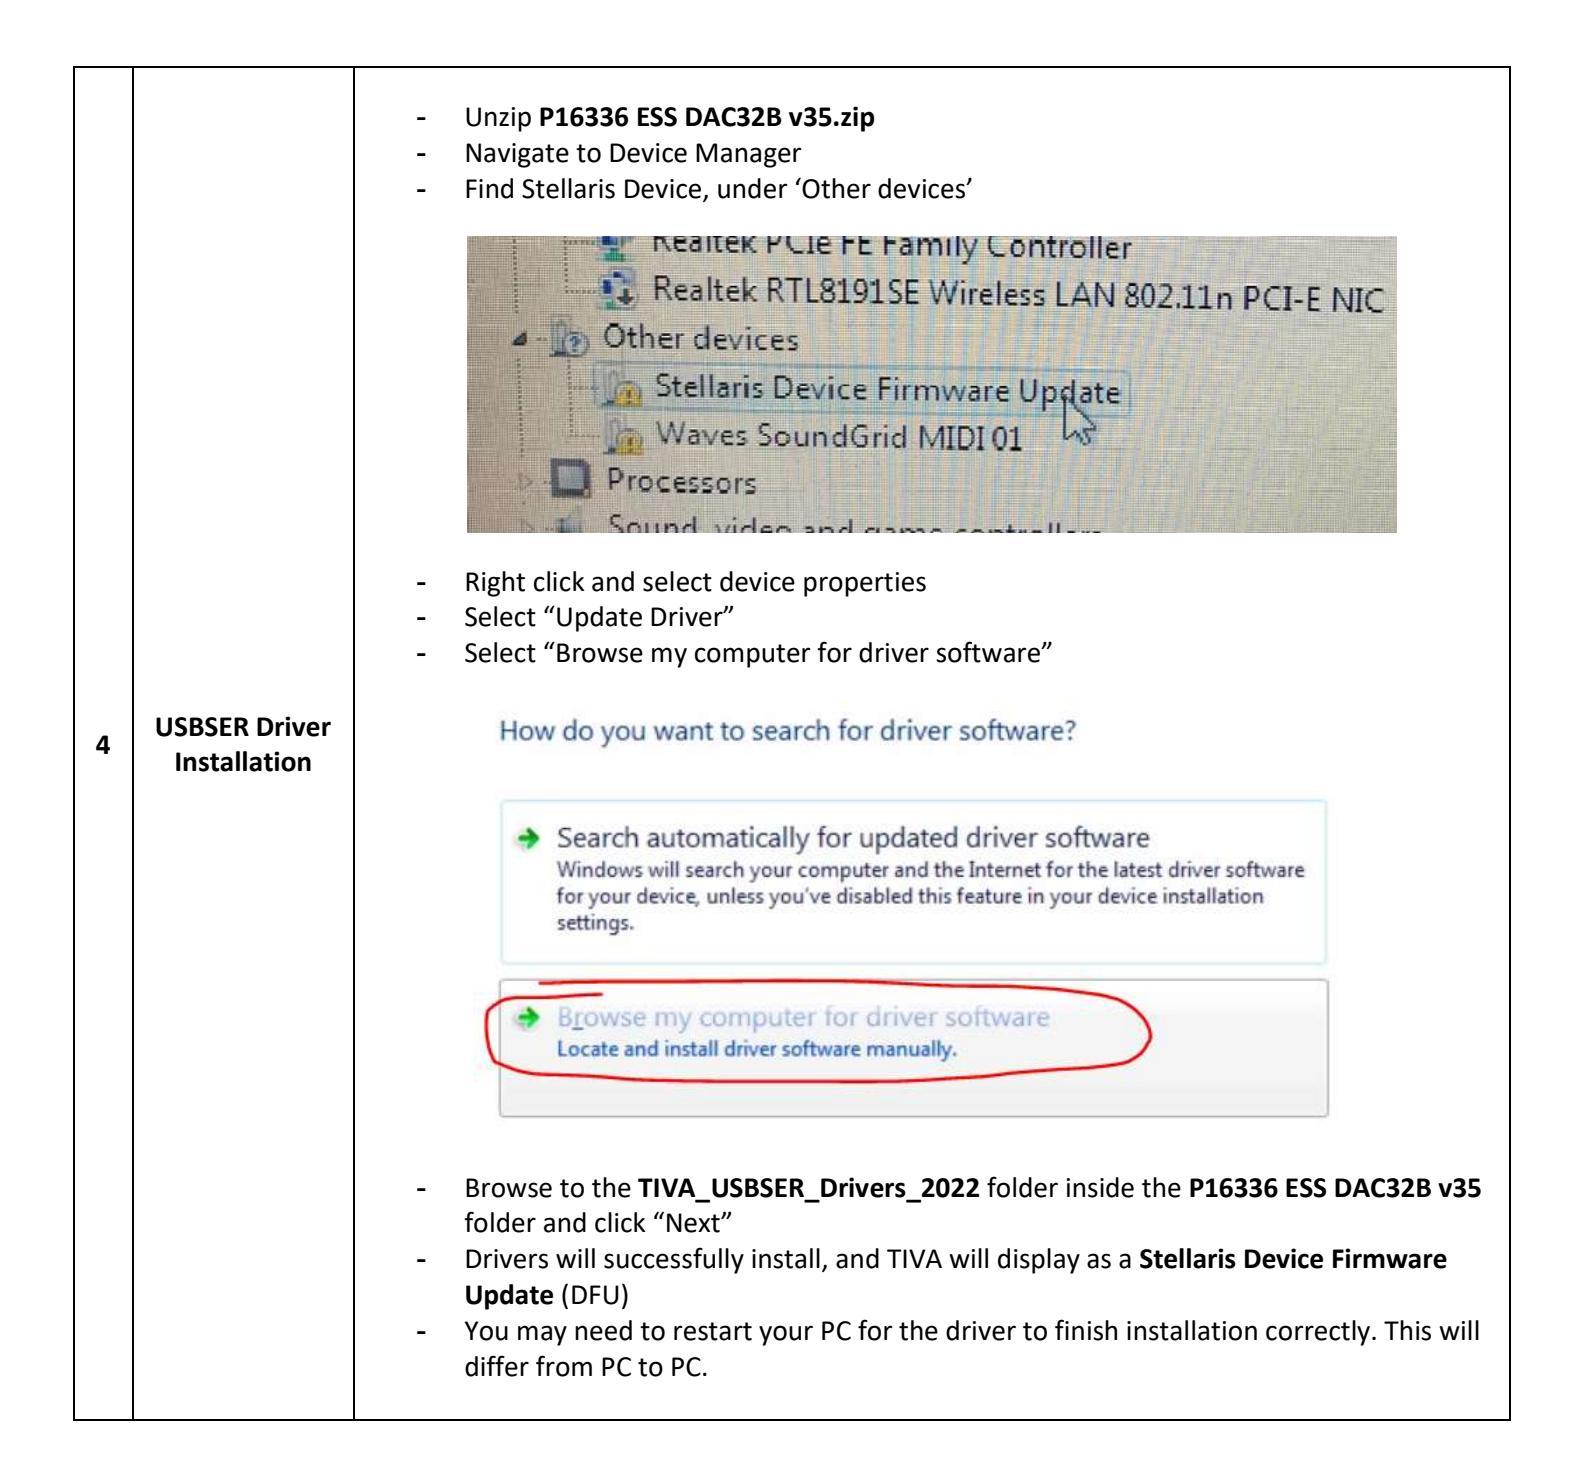
The firmware update process described below is only intended for these cards.

5	TIVA Programming	 Navigate to the SDRackCardTiva folder inside the P16336 ESS DAC32B v35 folder Den the folder and run 'SDRackCardTiva.exe' From "COM Port:" drop down menu, select <none> and click "Update Firmware"</none>
6	TIVA Programming	 A pop-up menu will confirm that the 32bit DAC TIVA DFU has been found Click "Confirm": voltages Device found: Vendor ID: 0x1CBE Certain Number: 00000000 Please confirm you want to update this device DeviceRemoval CC Confirm Cancel ortait for the progress bar to complete, then click "Close" The TIVA is now successfully programmed Close 'SDRackCardTiva.exe'

7	RESTART	 Unplug 32bit DAC card from SD rack (Power off) Remove USB cable from USB port on the card Remove the LK1 jumper from the bootloader setting (marked B/L) and set to normal Plug 32bit DAC back into SD rack Front panel GT and SPLIT LED will flash once during boot up.
---	---------	--
